## BMT 932 / 932 C Replacement of Utility Scrubber

Rev. 1.1 - 05. Mar. 2026

This Service Note explains the process of replacing the utility scrubber, after Scrubber Warning has been displayed.

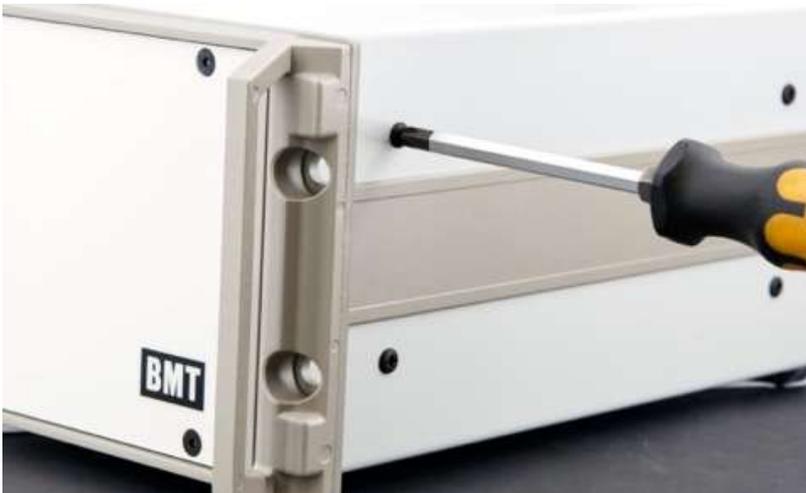
1. Open up the instrument's top panel with a Phillips Head screwdriver.

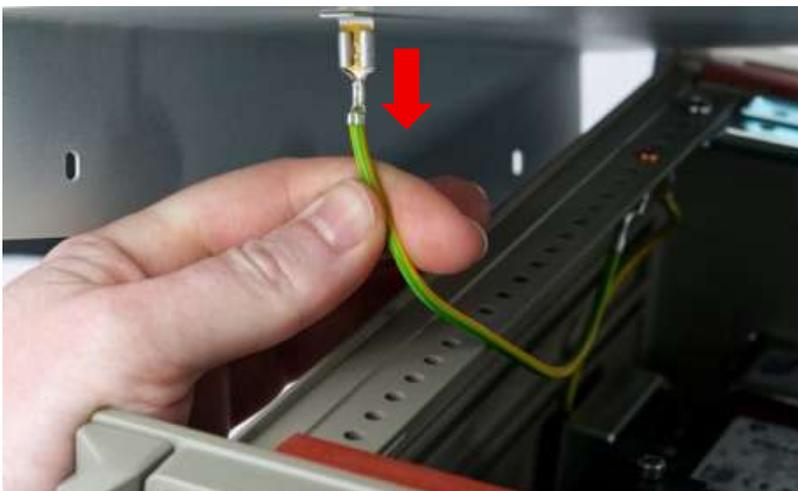
2. Unplug the grounding wire attached to the top panel.

7. Push the black Viton tubing on the grey nipple on top of the utility scrubber.
8. Repeat the steps in reverse order, to put the instrument back together.
9. **Do not forget to reattach the grounding wire to the monitor's top panel.**

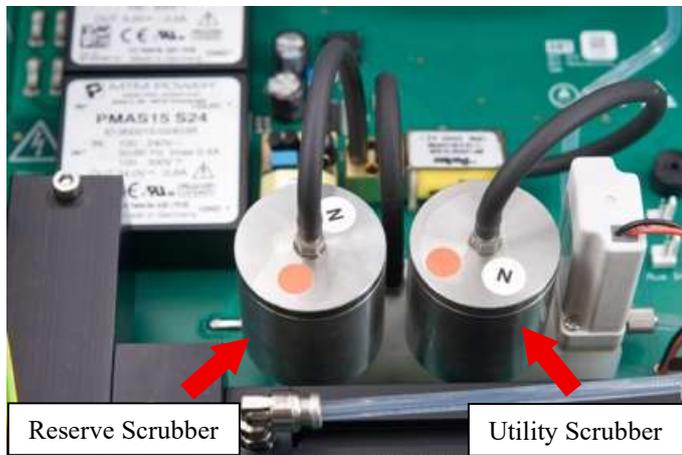
3. The black tubing from the utility scrubber has to be removed. Do not pull off the tubing by hand as it could tear.

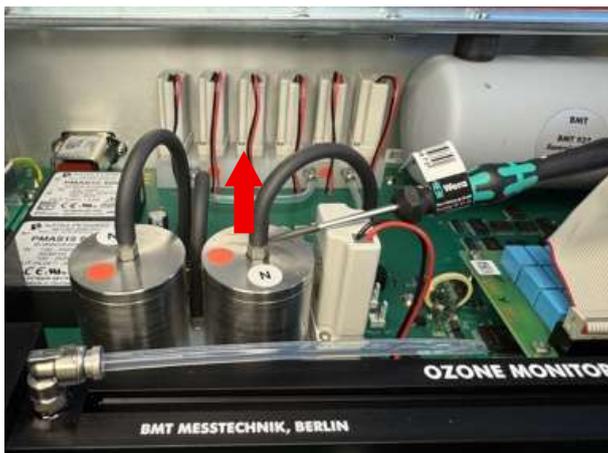
4. Use a flat screwdriver to push the tubing off.

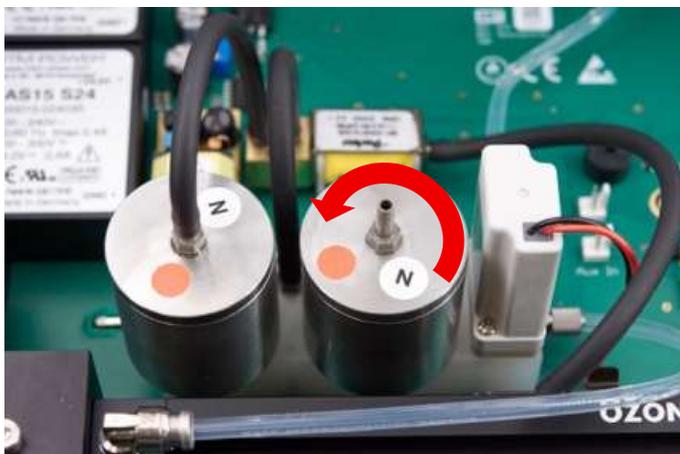
5. Remove the scrubber by turning it counterclockwise.

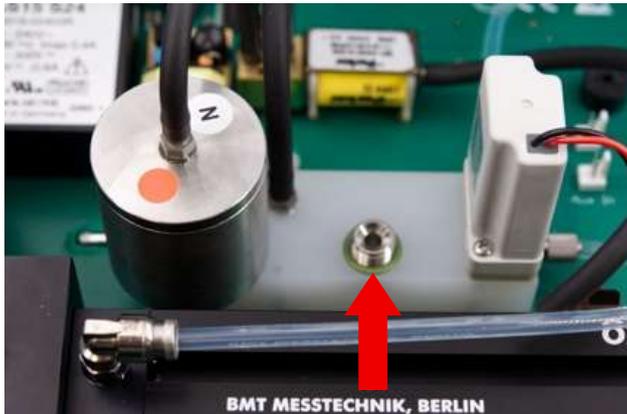
6. Screw in the new scrubber to the exposed thread. Make sure that the green O-ring is seated correctly.
